Illinois Commerce Commission  
Assessment of Commonwealth Edison Company  
Reliability Report and Reliability Performance  
for Calendar Year 2004

Pursuant to 83 Ill. Adm. Code 411.140

December 23, 2005

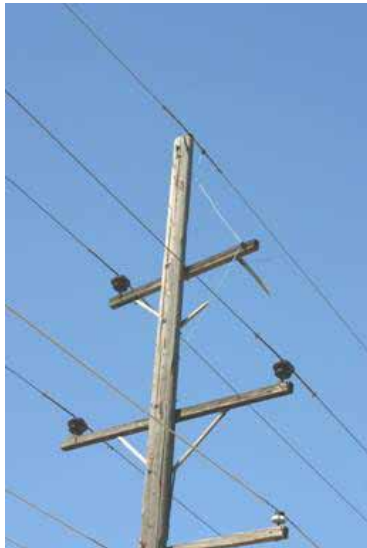
In some cases Staff noted the conditions of portions of circuits randomly observed by Staff while in travel within ComEd's service territory, going to and from locations of worst performing circuits, or while evaluating vegetation conditions in randomly picked areas. Staff observed some deficiencies (such as blown lightning arrestors, shell rotted poles, loose bolts, split or bad crossarms, and trees into the primary) that appear to be on par with the levels observed in previous years. See Pictures 1 and 2 or Appendix B.

**Picture 1 – Broken Wood Brace**

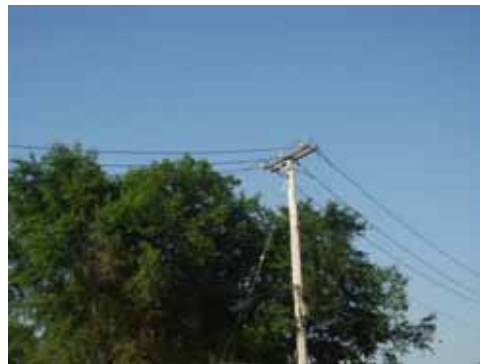
**Picture 2 – Trees in Primary**

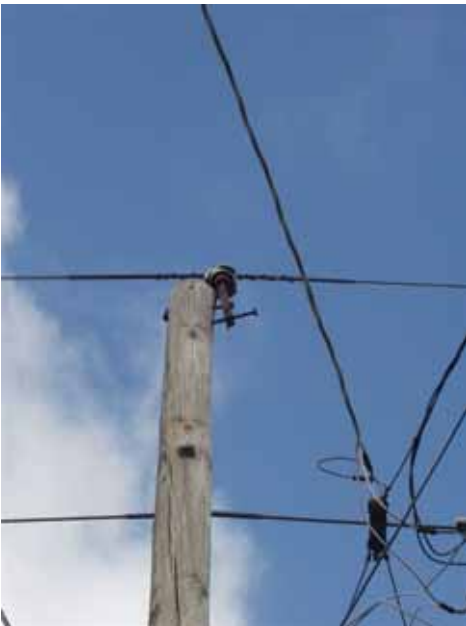
**Picture 3 – Broken Insulator**

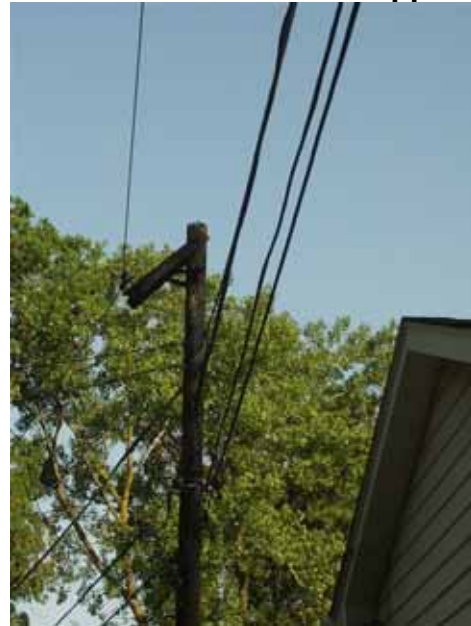
**Picture 4 – Broken Cross Arm Support**

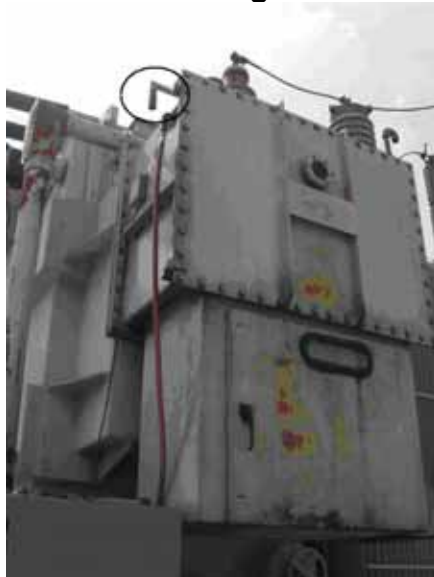
The most dramatic situation observed was the active venting of oil from a transformer load tap changer (“LTC”) compartment (not the bushings) at TDC 550 Clearing Substation during Staff’s inspection of the substation. The leak was from the area circled in Picture 5. ComEd personnel were aware of and were addressing the problem and from a reliability perspective everything appeared under control. Staff notes that ComEd could have saved some cleanup effort later if the leaking oil had been collected and contained rather than allowed to splash over control panels and nearby equipment.

**Picture 5 – Leaking Transformer**

Staff recommends that ComEd inspect insulating oil levels of substation equipment as appropriate and make adjustments as necessary.

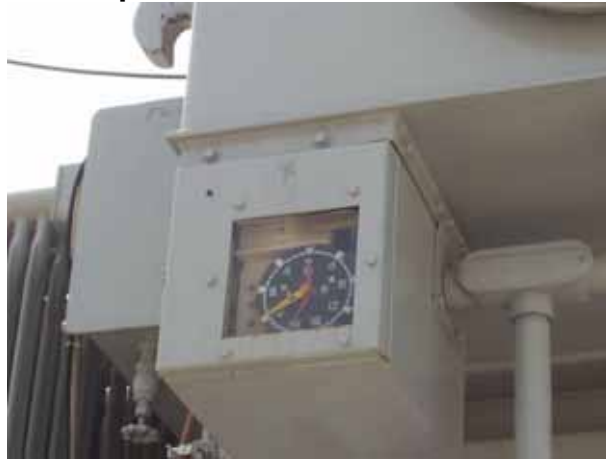
On a number of occasions Staff observed that load tap changers had been operated at extreme positions (see Picture 6) which could over time tend to wear of the equipment sooner and require more attention from personnel in order to maintain reliable operation. ComEd has indicated that they are aware of this

problem and its prevalence and are working to take appropriate corrective action<sup>17</sup>. Staff will be following these LTC issues in the future.

**Picture 6 – LTC Operated at Extreme Lower Limit and Neutral**

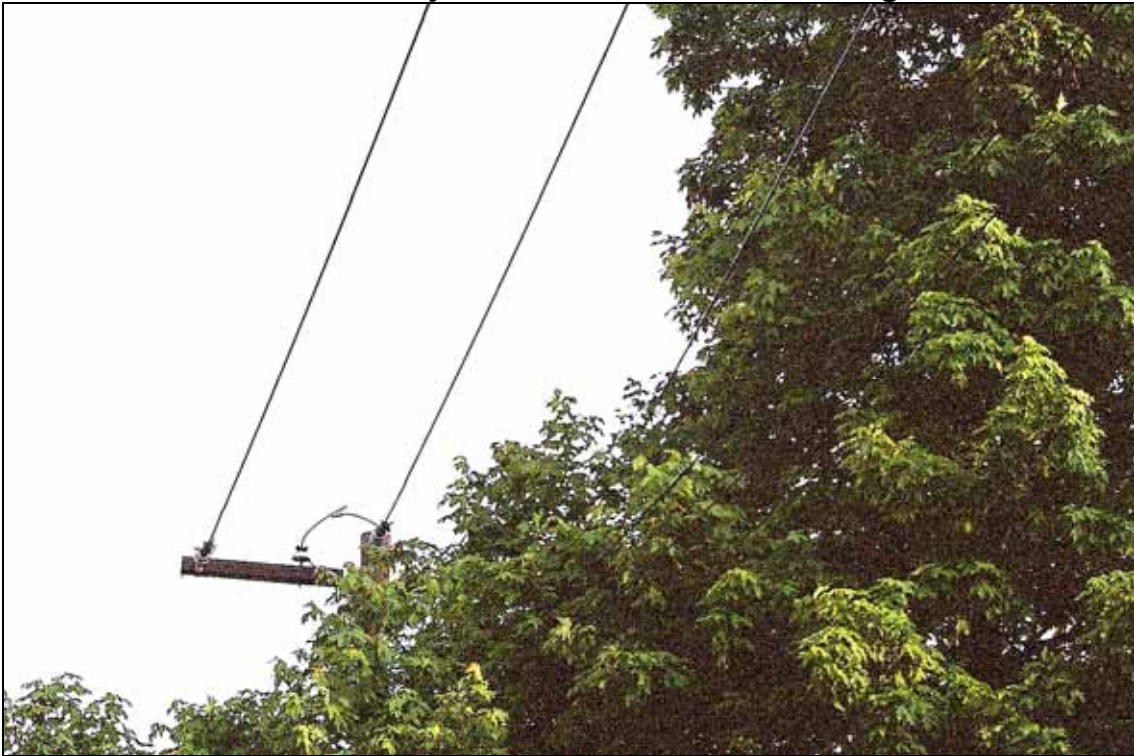
**Figure 1 (Photo 05M2)**

**Primary through a hard maple tree,  
12<sup>th</sup> Avenue just north of 6<sup>th</sup> Street, Sterling**

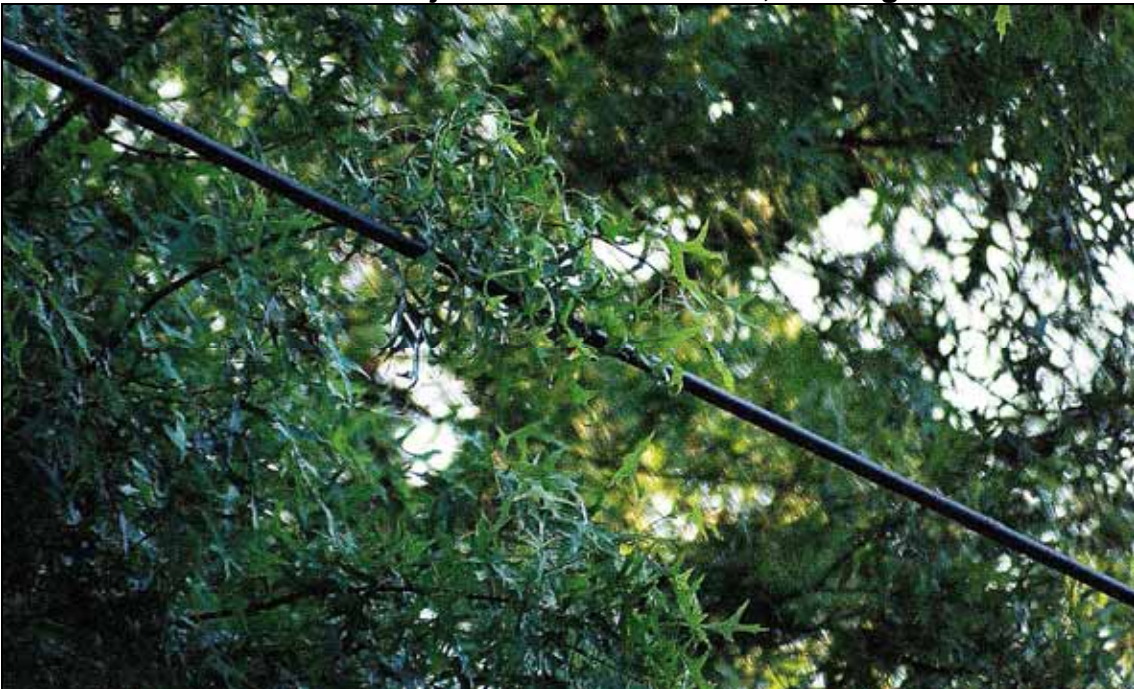
**Figure 2 (Photo 05M6)**

**Oak tree limb on primary conductor,  
12<sup>th</sup> Avenue just north of 6<sup>th</sup> Street, Sterling**

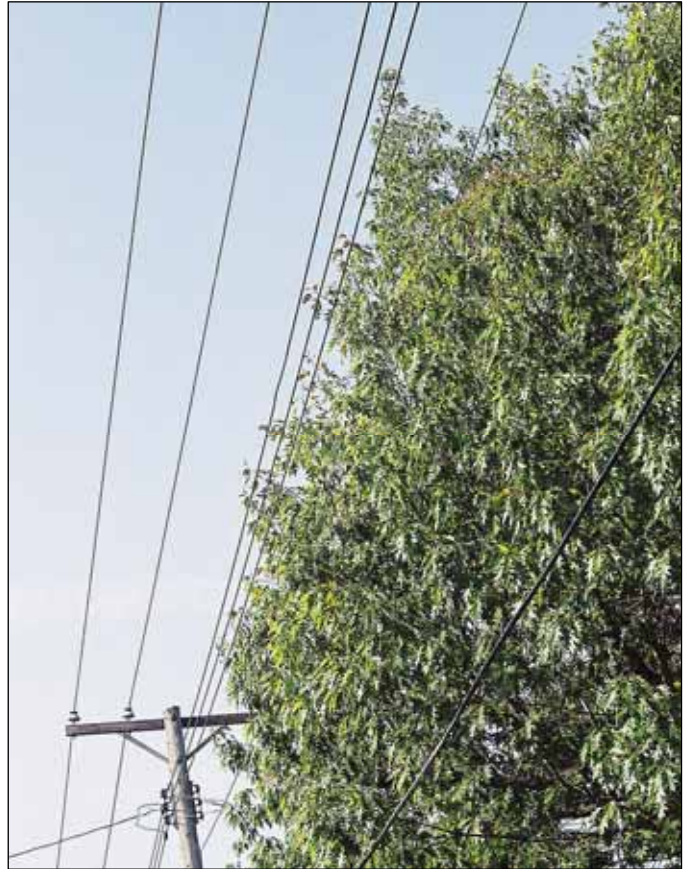
**Figure 3 (Photo 05M10)**  
**Primary burning an oak tree,**  
**5<sup>th</sup> Ave. south of LeFever Rd.,**  
**Sterling**

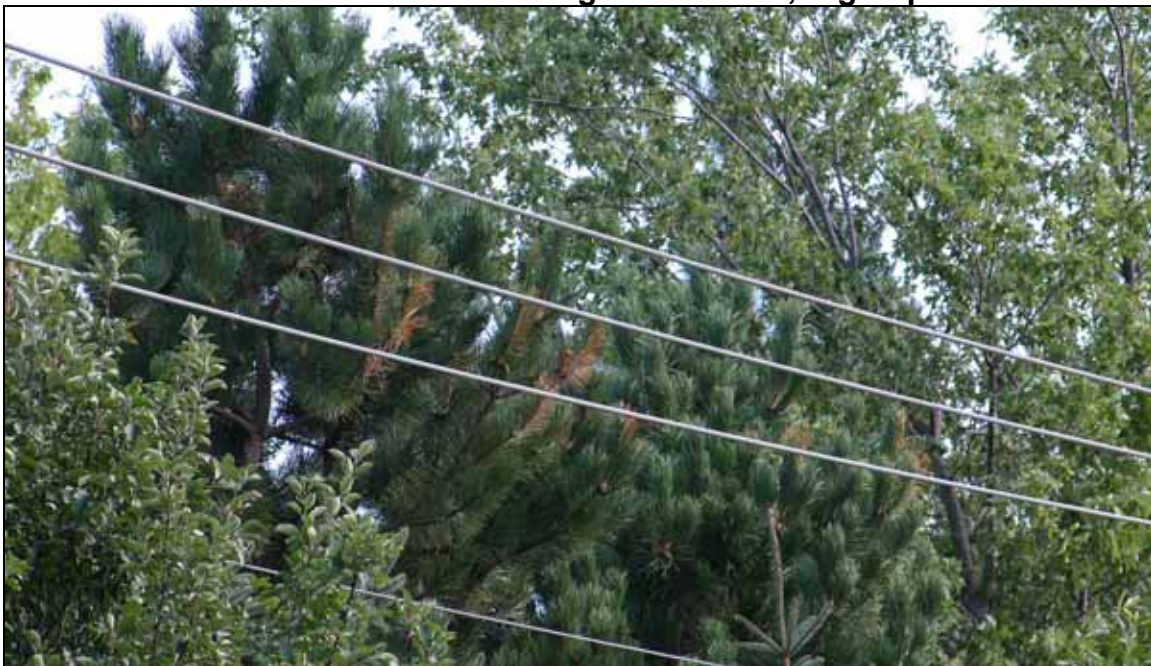
**Figure 4 (Photo 05-CE623a)**  
**Pine tree burned by 3-phase primary,**  
**Hanson Lane north of Edgewood Road, Algonquin**

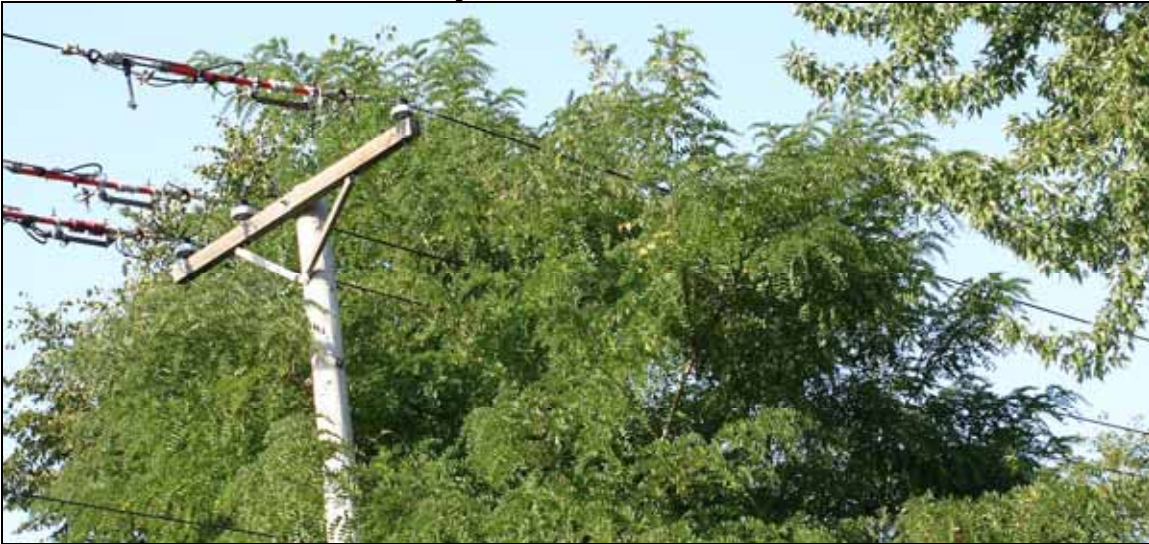
**Figure 5 (Photo 05-CE630a)**  
**3-phase primary through a black locust tree,  
Illinois Avenue just west of Iowa Street, Aurora**

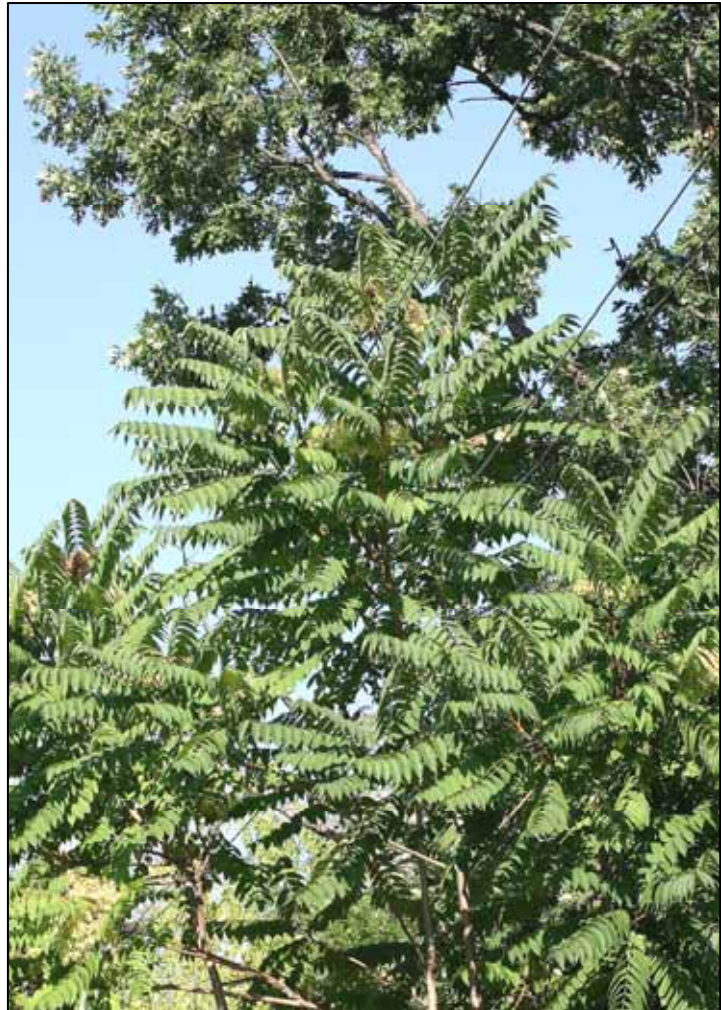
**Figure 6 (Photo 05-CE634a)**  
**Tree of Heaven growing through  
single-phase primary,  
North Ave. east of Kendall St.,  
Aurora**

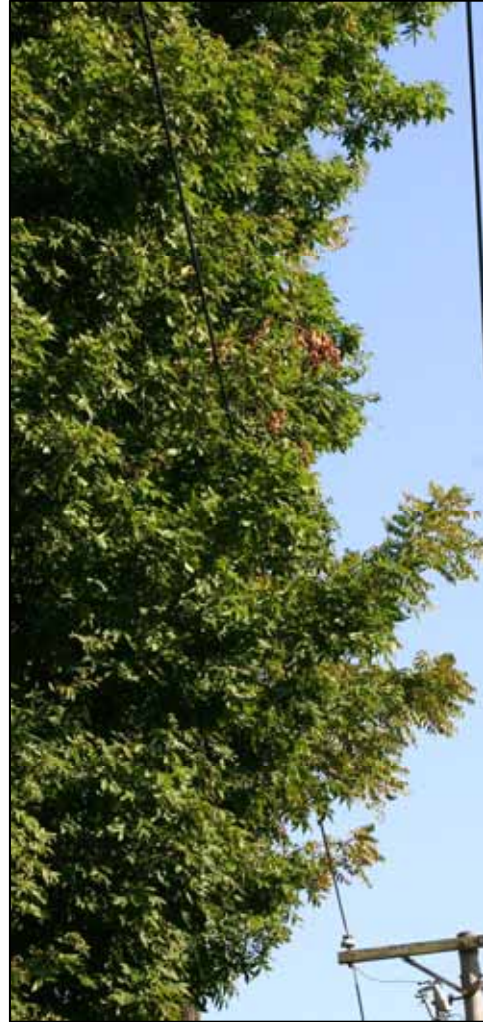
**Figure 7 (Photo 05-CE636a)**  
Primary through a bitternut hickory tree,  
Farnsworth Avenue south of Summit Avenue,  
Aurora

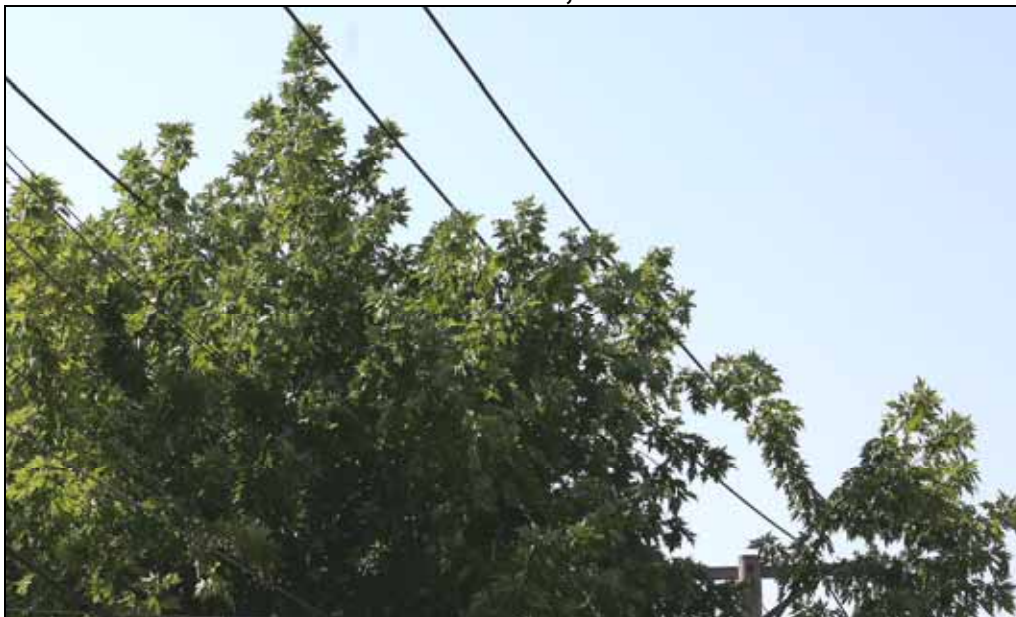
**Figure 8 (Photo 05-CE641a)**  
Silver maple tree growing through primary,  
Jackson Street south of 5<sup>th</sup> Avenue, Aurora

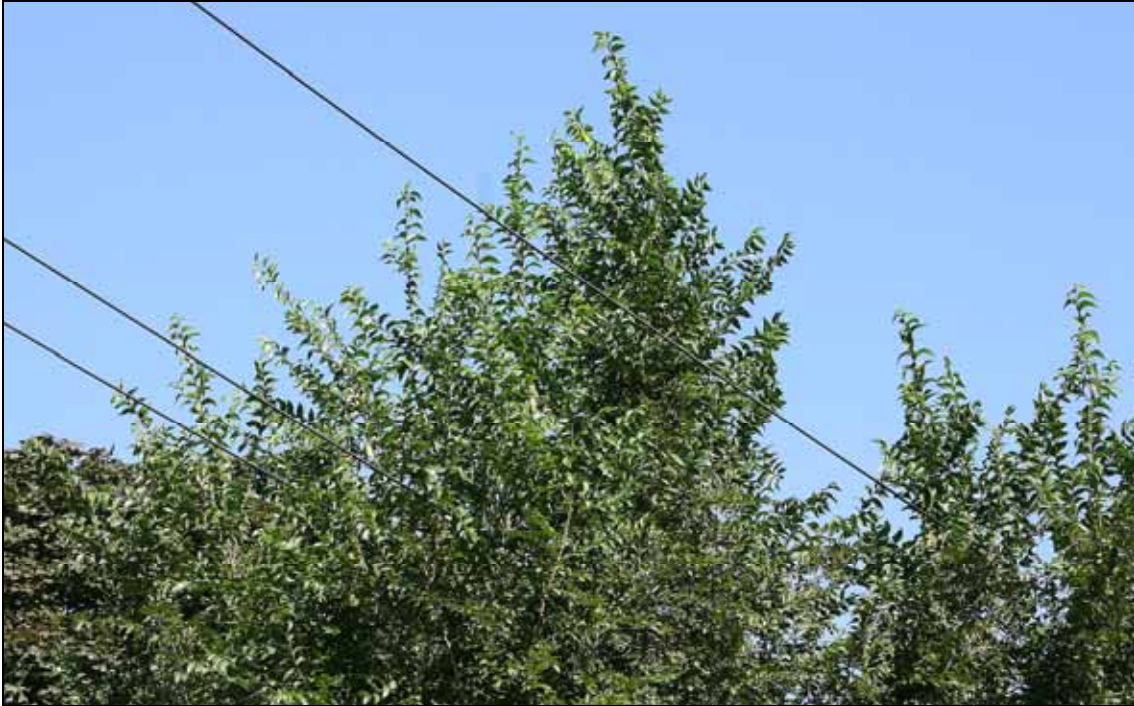
**Figure 9 (Photo 05-CE648a)**  
**3-phase primary through a Siberian elm tree,**  
**Union Street south of Columbia Street, Aurora**

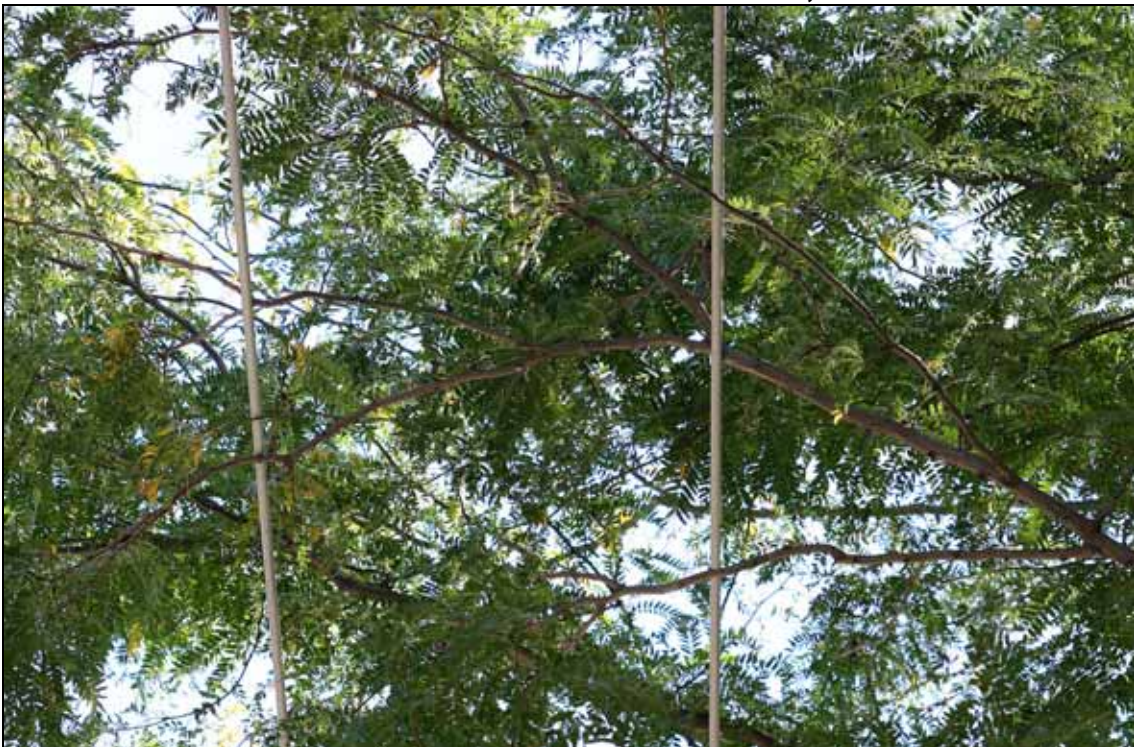
**Figure 10 (Photo 05-CE656a)**  
**Honey locust tree grown into (over & under) 3-phase primary,**  
**Prairie Street west of Elmwood Avenue, Aurora**

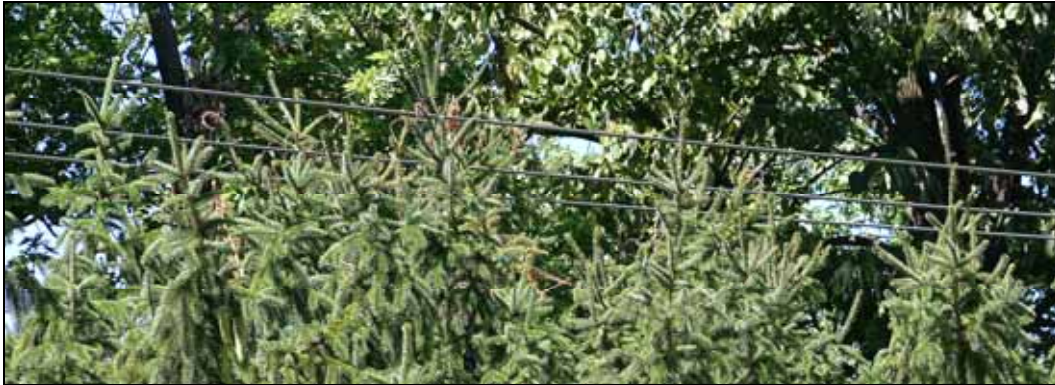
**Figure 11 (Photo 05-CE658a)**

**Spruce trees growing into 3-phase primary (with burning),  
Clarendon Hills Road south of 68<sup>th</sup> Street, Darien**

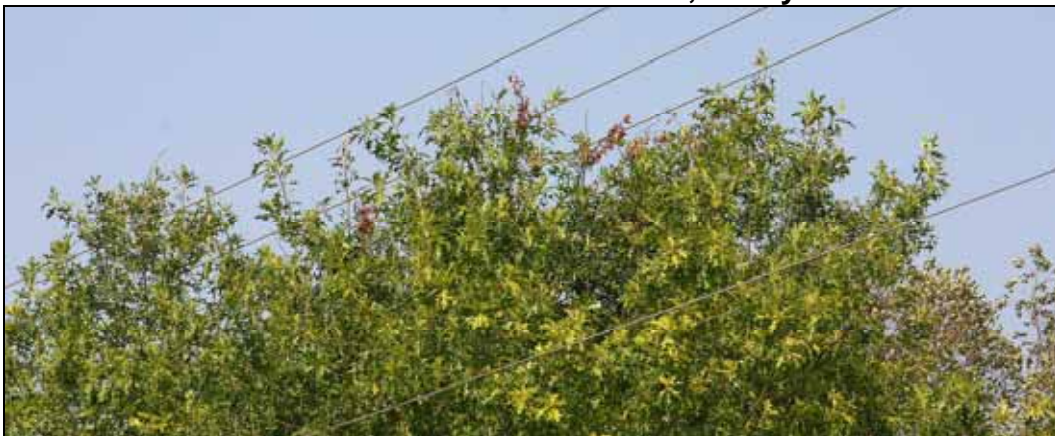
**Figure 12 (Photo 05-CE686a)**

**Pin oak trees into 3-phase primary (with burning),  
84<sup>th</sup> Avenue south of 163<sup>rd</sup> Street, Tinley Park**

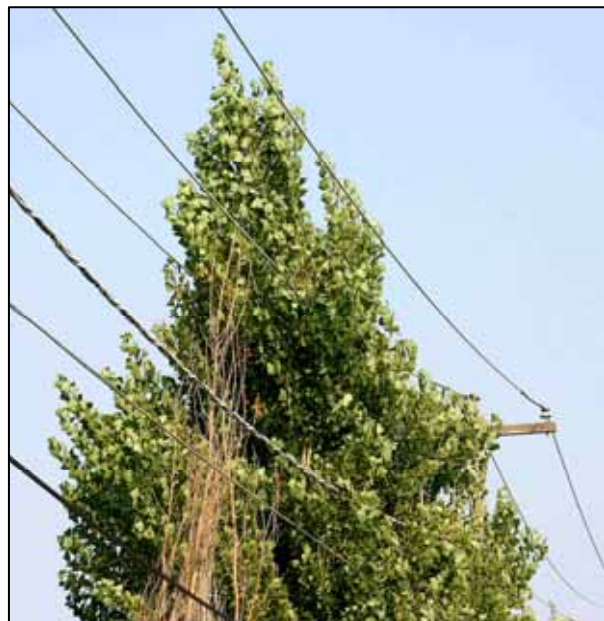
**Figure 13 (Photo 05-CE692a)**

**Lombardy poplar trees through and  
engulfing 3-phase primary,  
175<sup>th</sup> St. west of Sandalwood Dr.,  
Tinley Park**

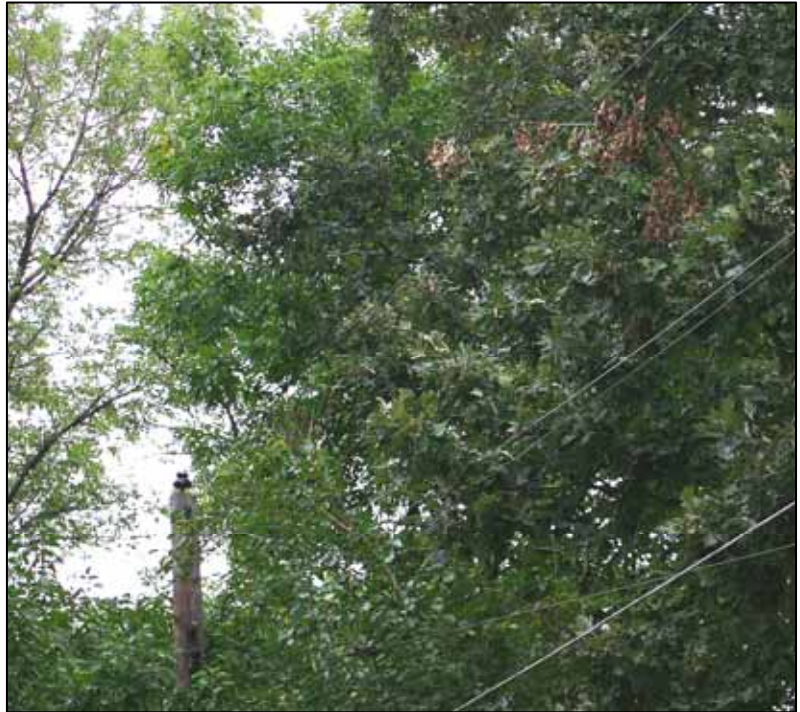
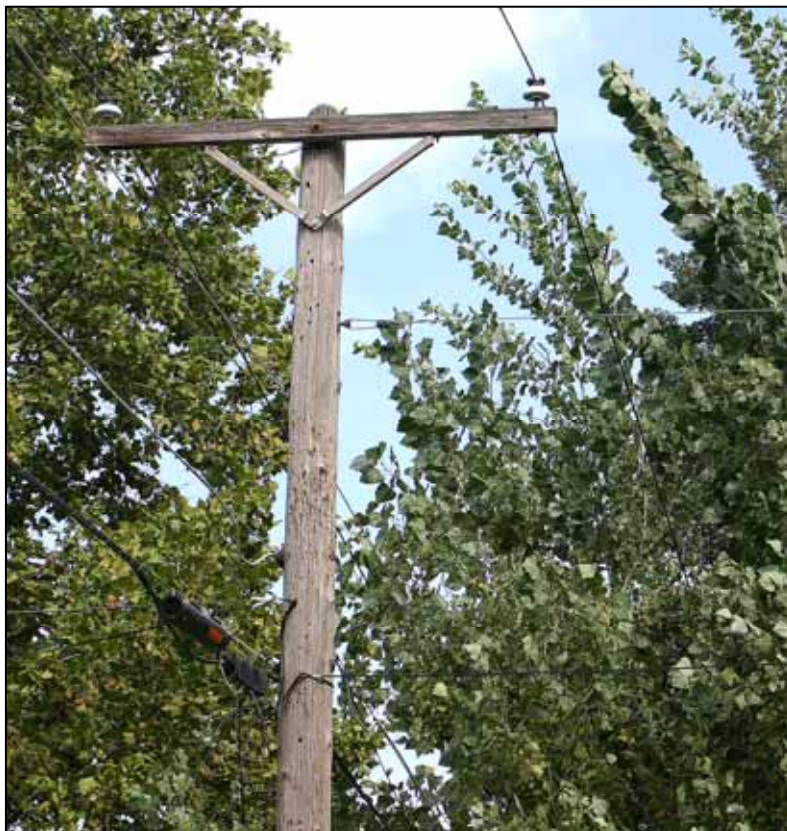
**Figure 14 (Photo 05-CE698a)**  
Primary through oak tree  
(with burning),  
Oakley N. of Lakeview Ave.,  
Joliet

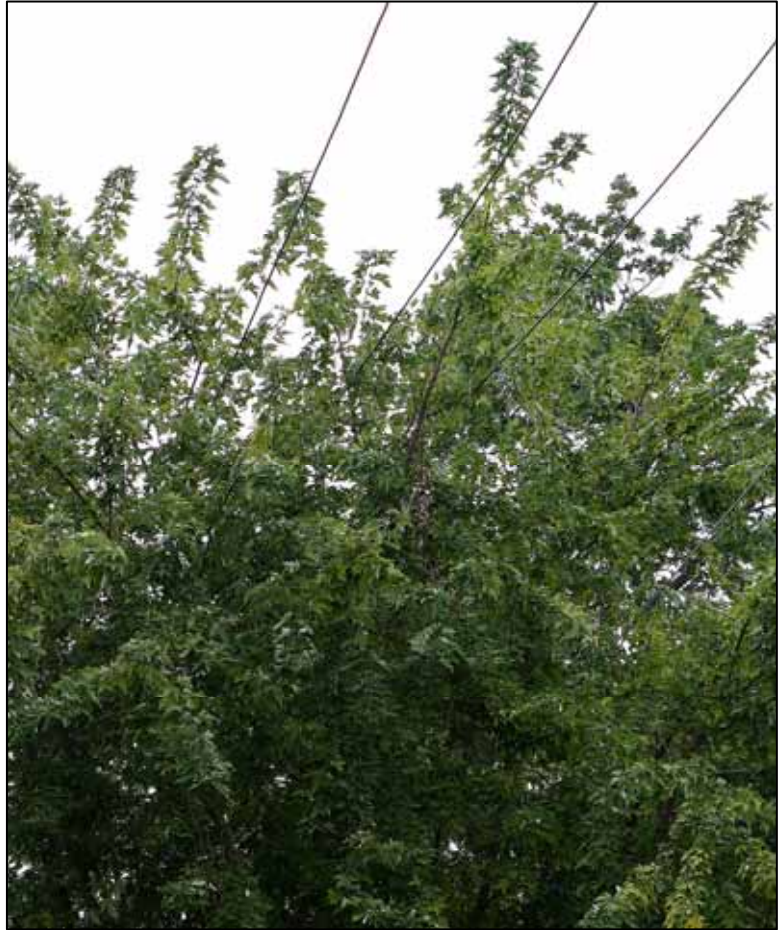
**Figure 16 (Photo 05-CE727a)**  
3-phase primary through a  
silver maple tree,  
Mill St. south of North St.,  
Pontiac

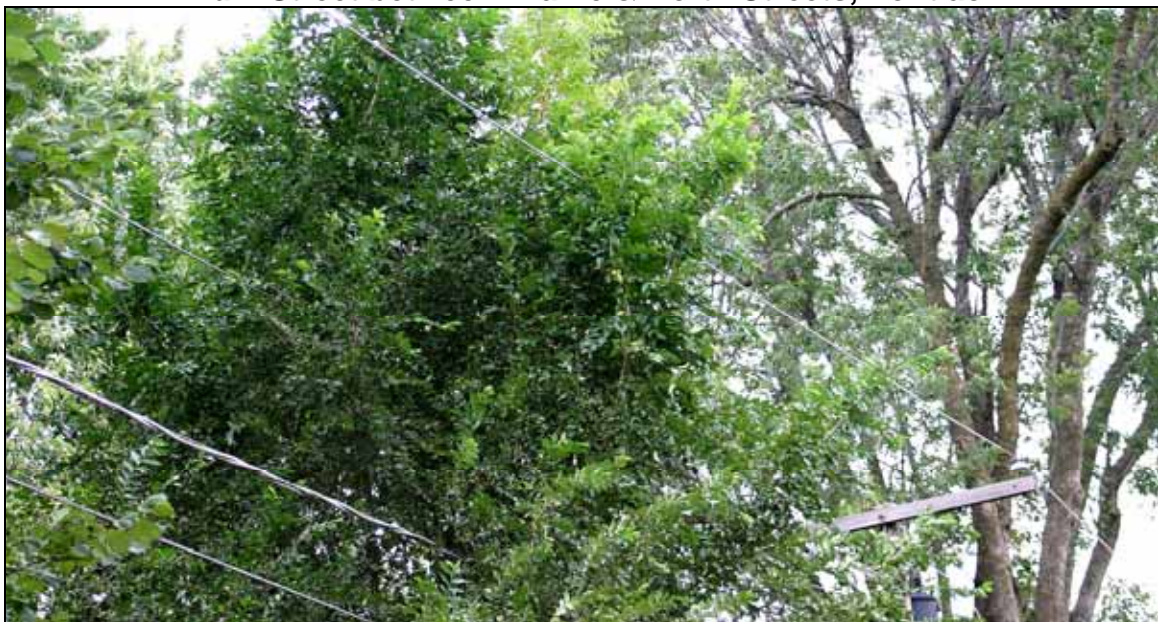
**Figure 17 (Photo 05-CE729a)**  
Primary through elm trees,  
Plum Street between Prairie & North Streets, Pontiac

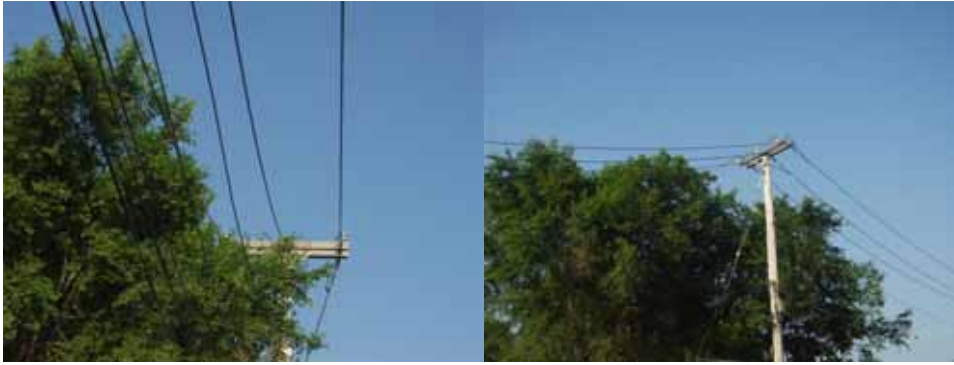
P6130004 & 5 -- While driving from TSS 150 to inspect worst performing circuit Z15077 Staff noted on an unidentified circuit that the field side phase [along E 100<sup>th</sup> St between Torrance Ave on the West and Muskegon Ave on the East] was into the trees. Also, near this location a slack down guy was observed.

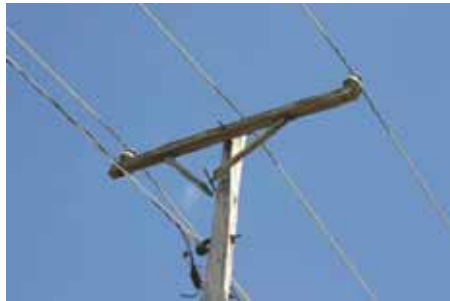
Photo 106-0613 (8/31/05).....Wood braces disconnected from pole (bolt totally out of pole), on Ware St. east of Seminary St., Woodstock. **(ComEd has already fixed this one.)**

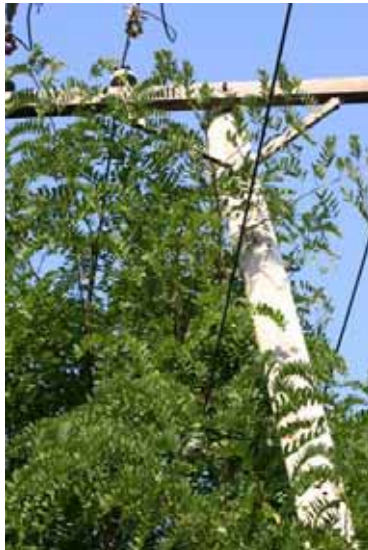
Photo 106-0631 (9/1/05).....Neutral spool out of secondary clevis, on Illinois Ave. just west of Iowa St., Aurora.

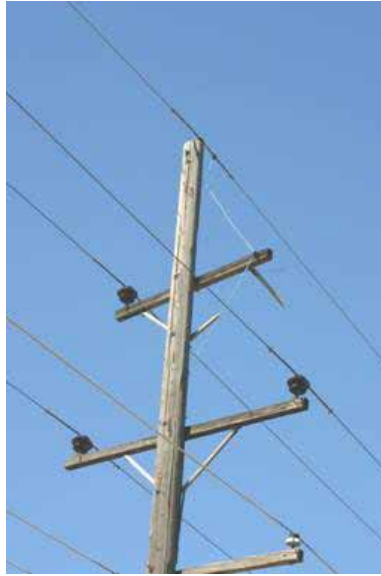
Photo 106-0662 (9/1/05).....Broken wood brace on 34 kV line, on Cass Ave. in front of Darien Office Bldg. (8141-8185 Cass Ave.), Darien.
